Technical Preservation Services
Preservation Assistance Division
National Park Service
U.S. Department of the Interior
Washington, D.C.

Interpreting the Secretary of the Interior's Standards for Rehabilitation

Volume III

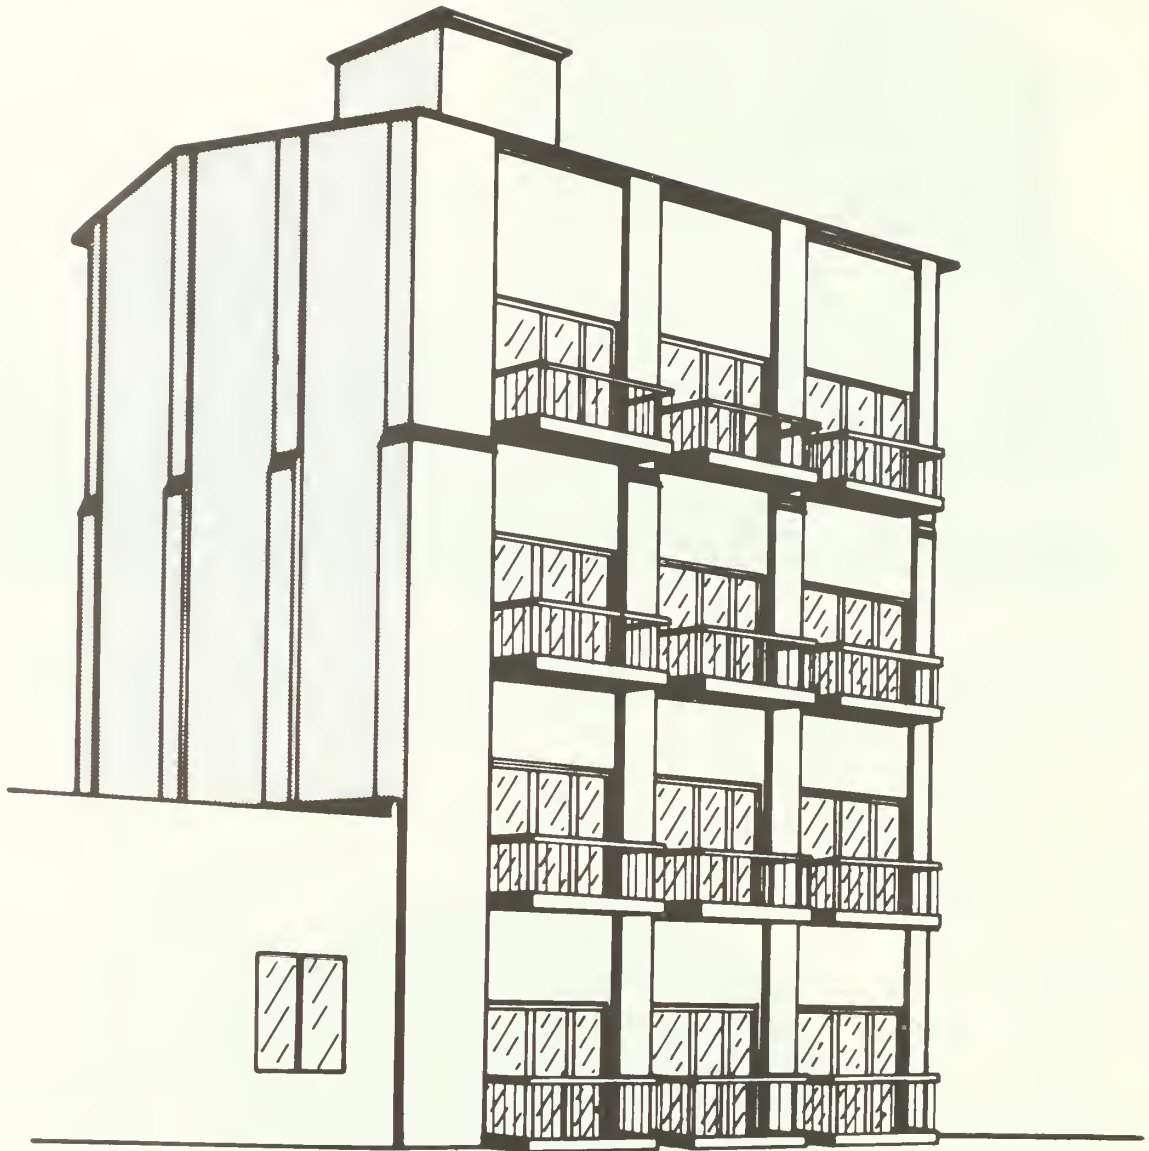
3. The rehabilitation proposal involved cutting windows on two highly visible side elevations and adding balconies. The National Park Service determined that the degree of change to accommodate this particular re-use proposal was not consistent with the historic character of the building; thus, approval was denied.

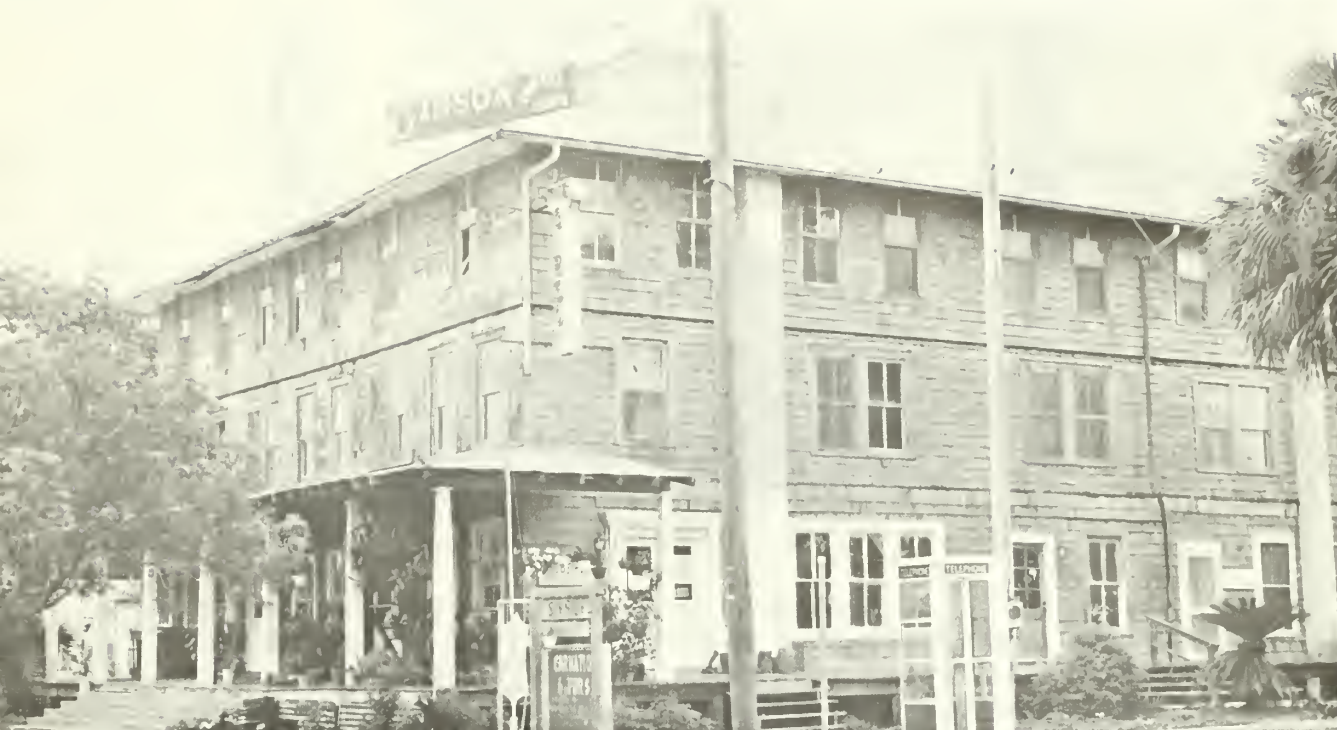
2. The hotel in 1984, prior to rehabilitation. The cupola and dormers are missing, and although a one-story front porch spans the primary elevation, it bears little resemblance to the two-story historic porch shown in the 1907 photograph. The hotel was certified as contributing to the significance of the historic district in its existing condition.

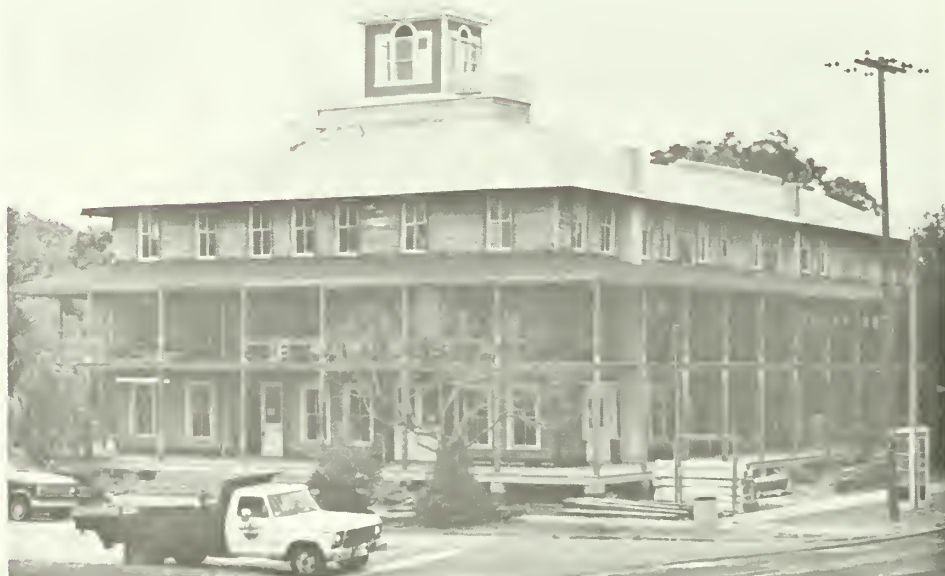
5. Hotel under rehabilitation for tax benefits. The restored cupola and two story front porch can be seen. On appeal, the Region's denial was upheld. There was neither photographic documentation nor physical evidence to support restoration of the building to the appearance shown here. The result was a "selective" restoration of architectural features that--while commercially appealing--could not be historically documented to the 1907 or the 1920 appearance.

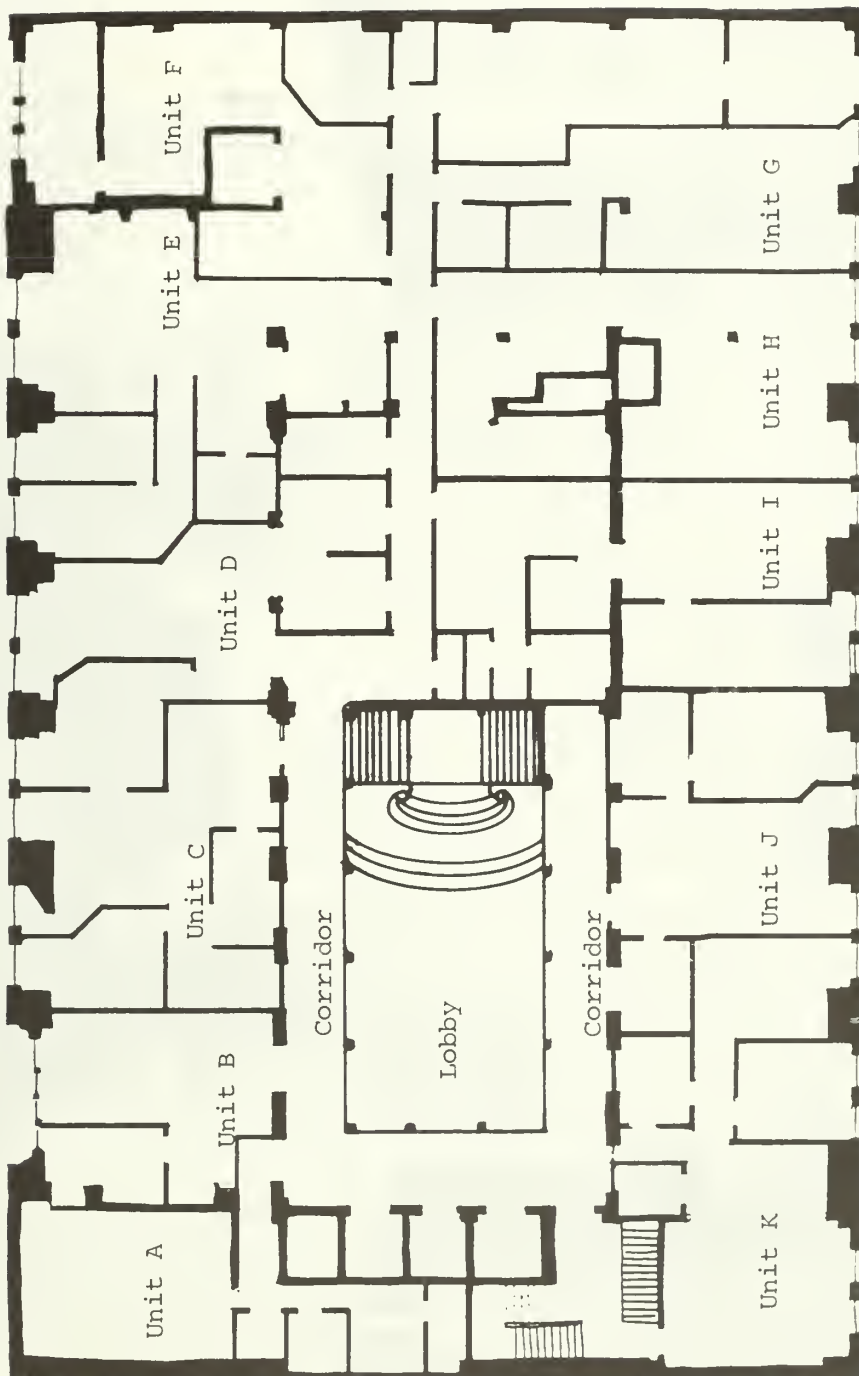
5. Lobby and adjoining spaces after rehabilitation. The palm room and dining room have been subdivided. A new partition directly behind the decorative screen has destroyed the progression of spaces that marked the original design.

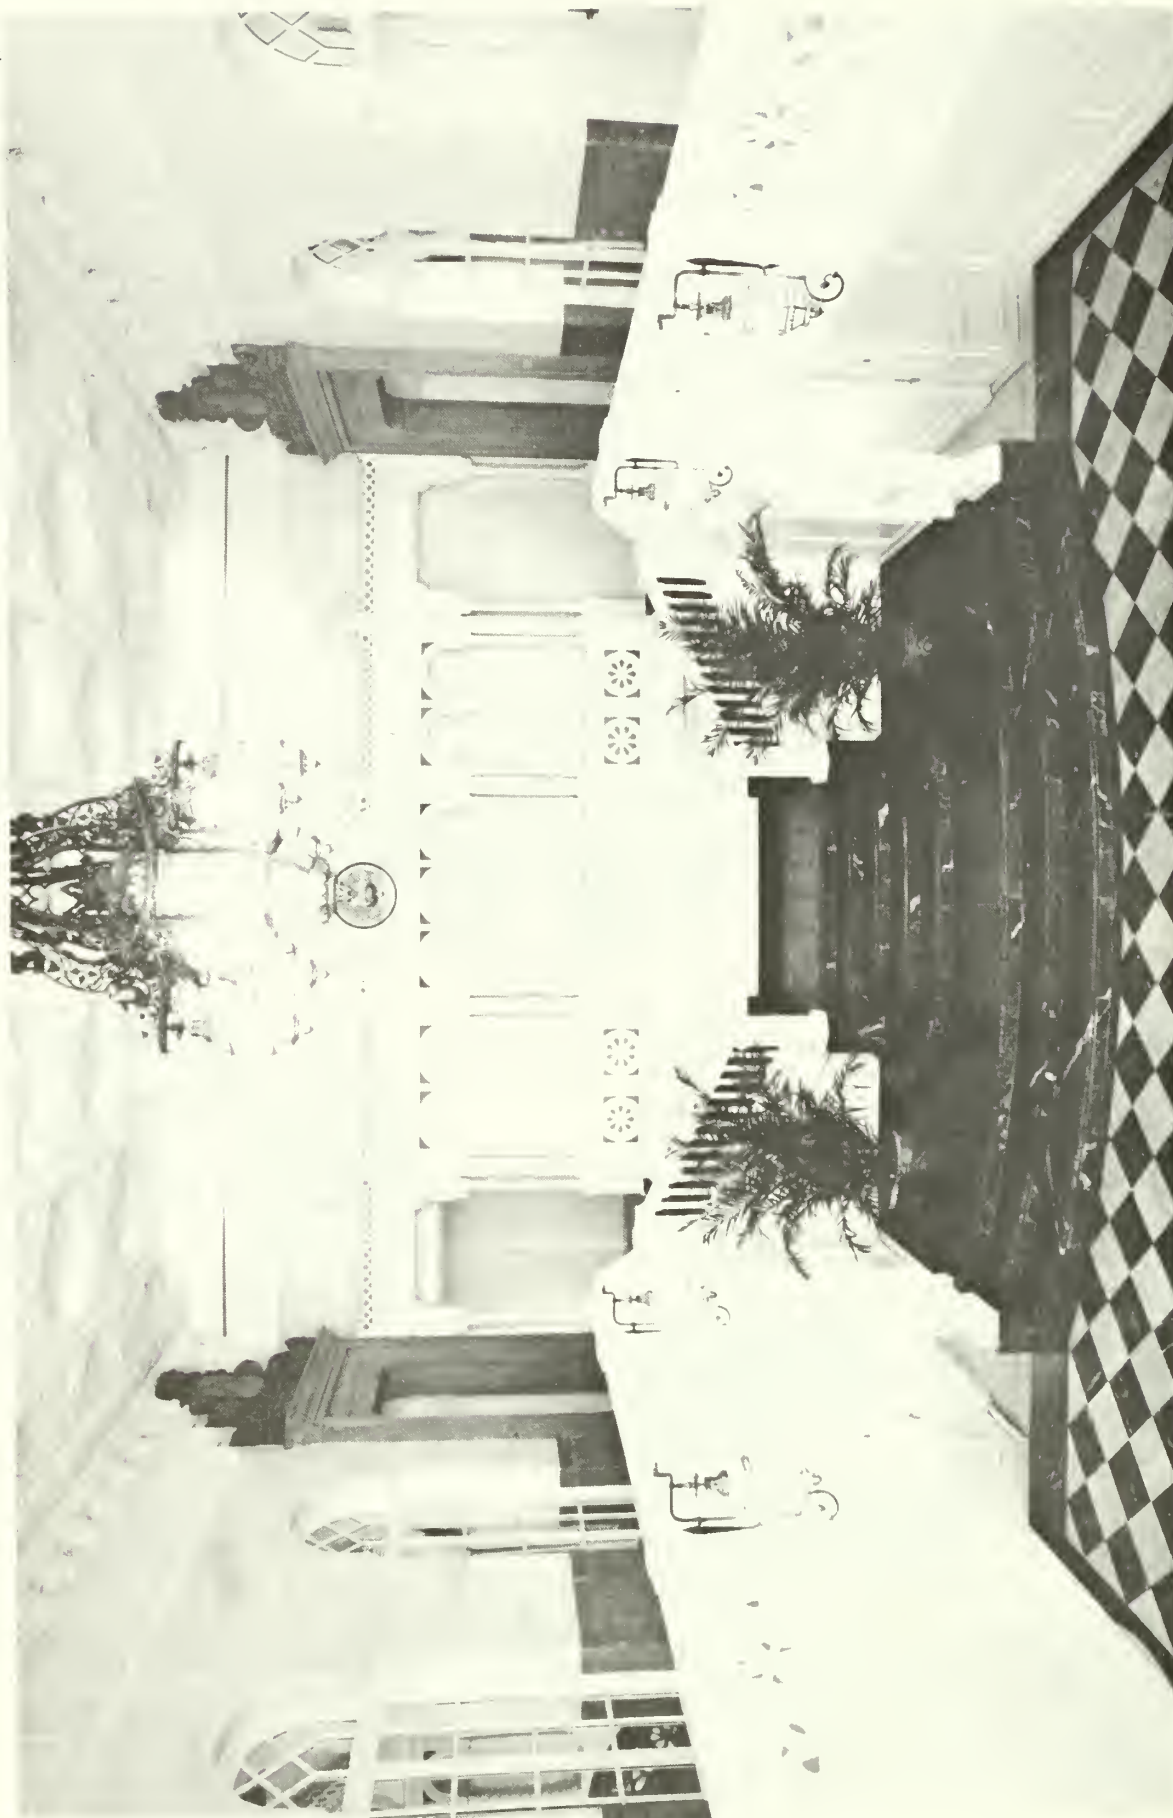
6. Lobby after rehabilitation. Partition behind screen closes off palm room and dining room from the lobby.

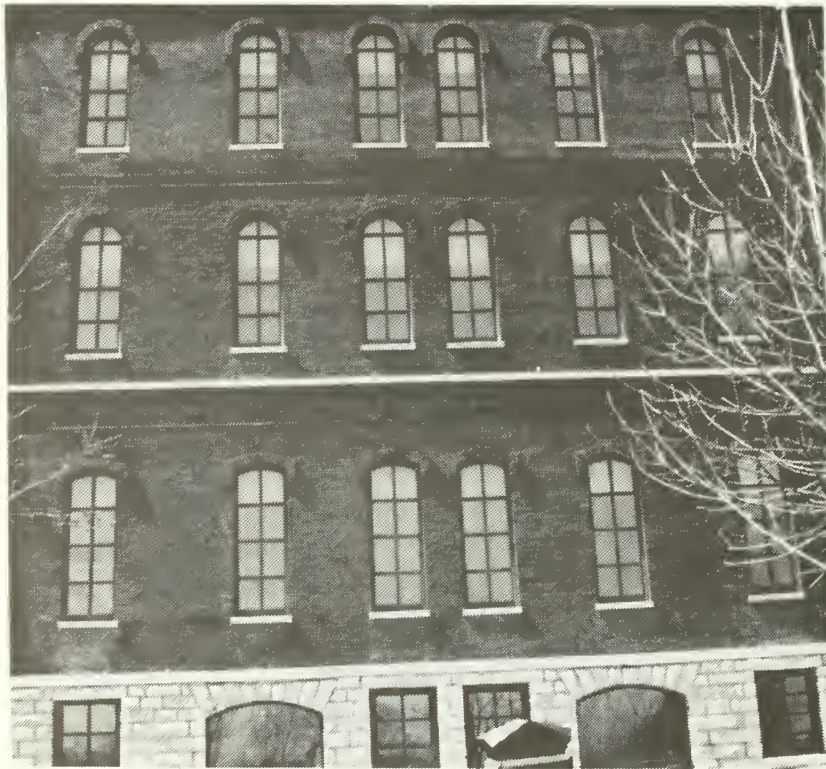
4 and 5. After rehabilitation, there is a striking change in the appearance of the entire facade due to the installation of inappropriate replacement windows. In addition to the obvious color disparity, the unit is noticeably on one plane rather than double-hung. The muntins are also much heavier and there is no meeting rail.

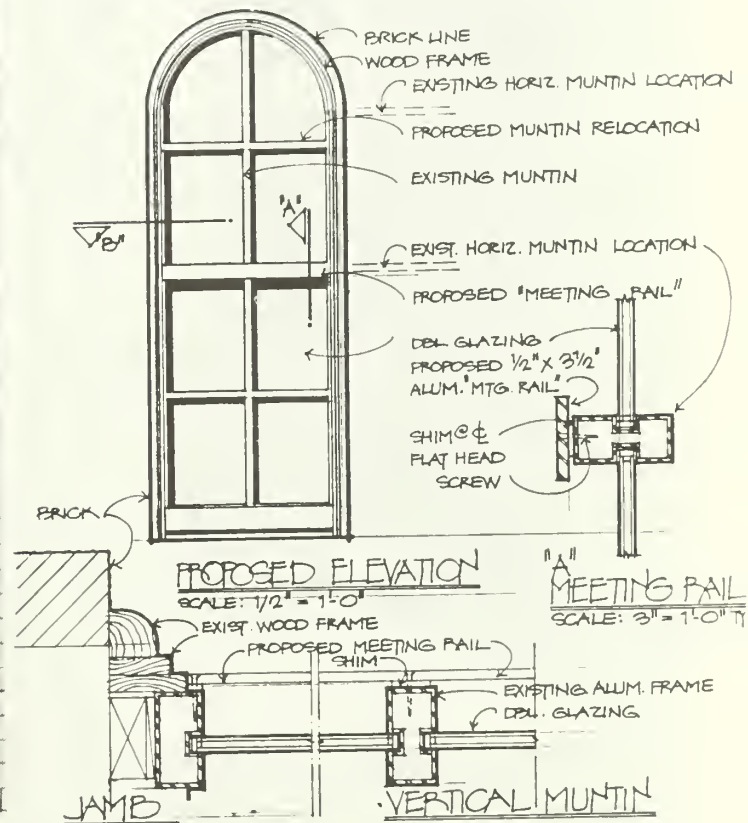
6. In an attempt to bring the inappropriate four-over-four replacement units (see 4 and 5.) into conformance with the Standards, two alternatives were proposed. In proposal A, the horizontal muntin at the top would be relocated so that all eight lights would be of equal size like the original. A 3 1/2" wide aluminum strip would be applied in an attempt to recapture some aspects of the meeting rail. Even after these adjustments, however, the upper and lower sash would read as a single, fixed unit; the muntins are also too wide and too flat.

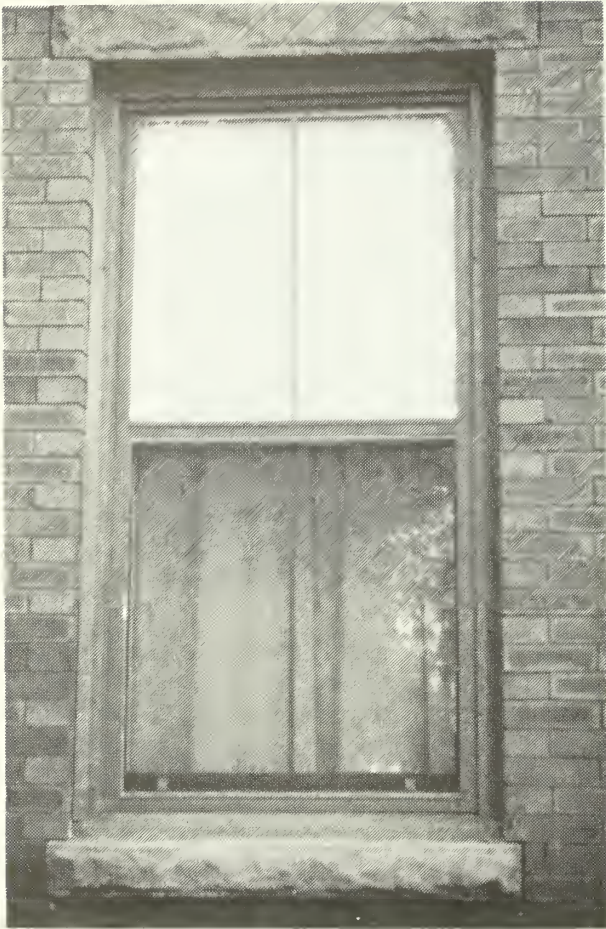
3. Post-rehabilitation photograph of aluminum replacement window. The vertical muntin was sandwiched within the insulating glass and the double-hung appearance changed since the screen panel was installed directly below the fixed upper sash.

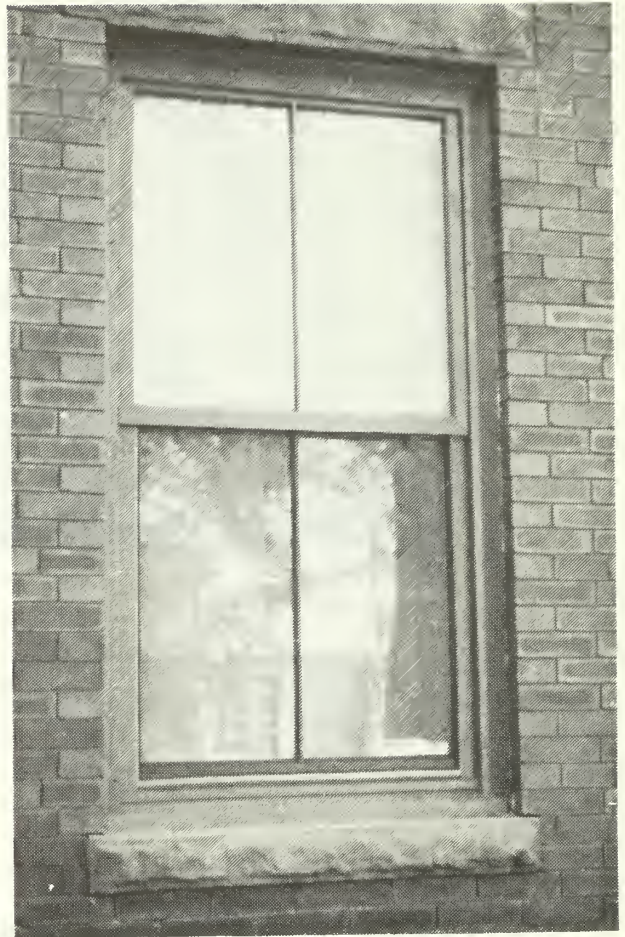
4. Aluminum replacement window with a wood mock-up of an applied unglazed sash frame and muntin placed over the upper aluminum sash. The applied frame and muntin look like temporary add-ons, rather than matching the historic sash.

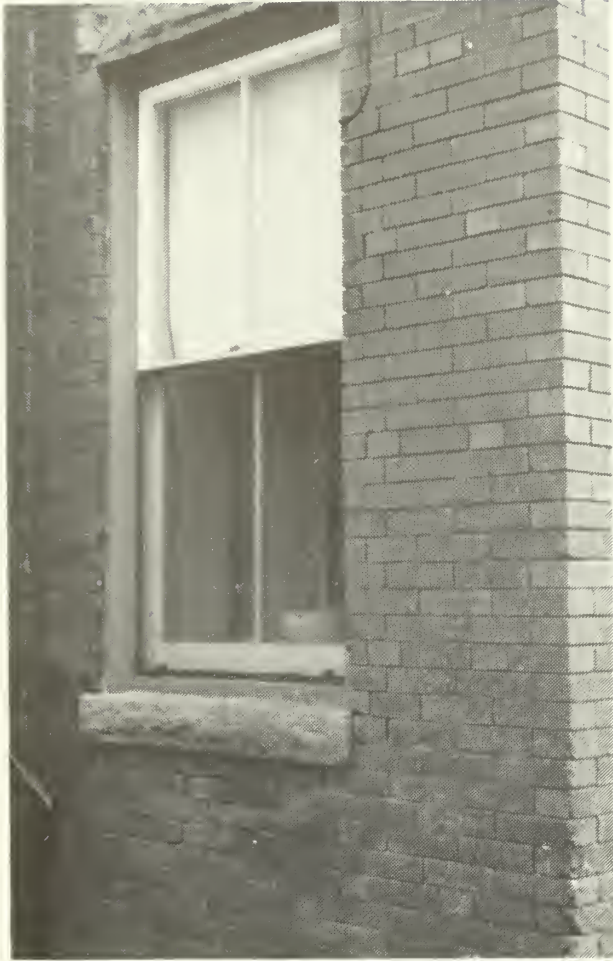
5. New wood replacement window as approved. If possible further refinement (although not required in this case) would have been to install the half screen on the inside rather than on the front of the upper and lower sash.

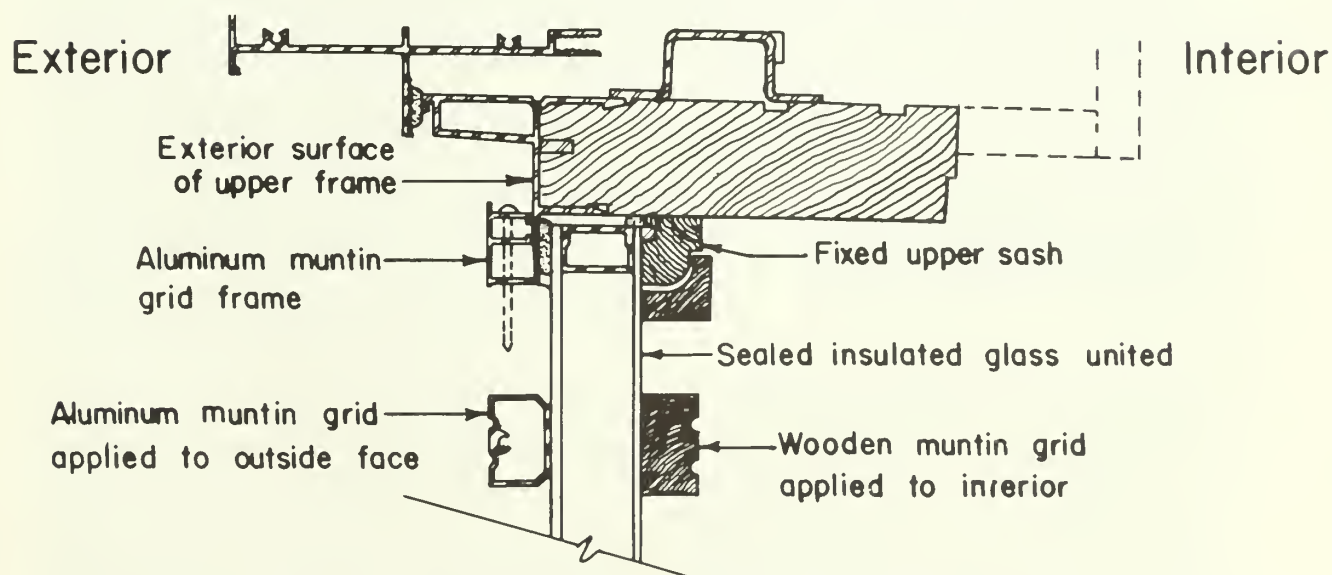
6. Shop drawing showing applied muntin grid projecting beyond the exterior surface of the sash. Also note rectangular shape and the two grooves on the interior and exterior muntin grids which produce the ribbed appearance and additional shadow lines that did not exist on the historic windows.

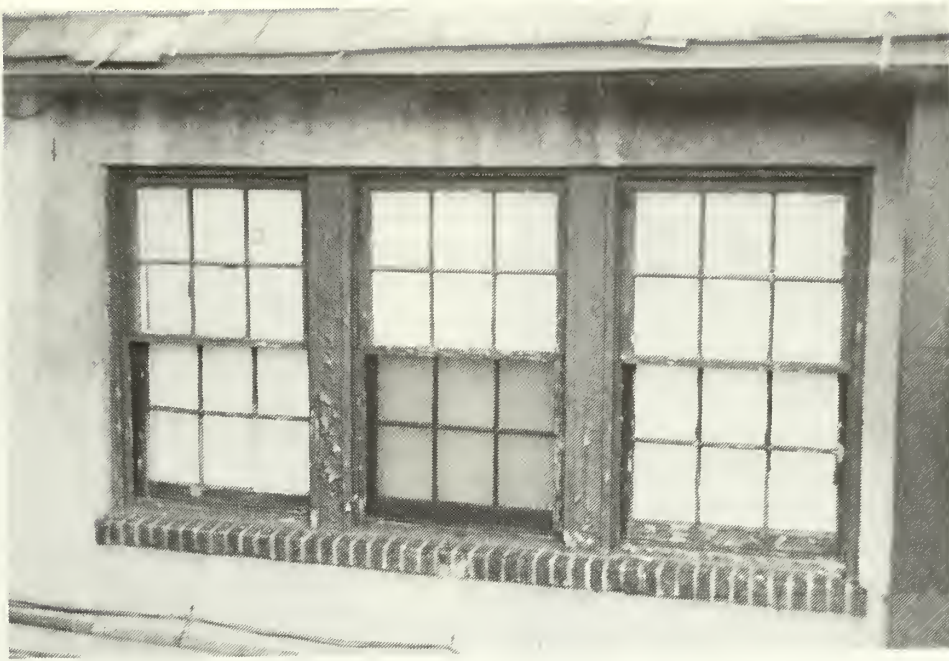
4-5. Pre-rehabilitation views of the deteriorated historic windows. Note beaded mullion above, thin muntins, meeting rails and sash on paired windows and the simple double-hung window below.

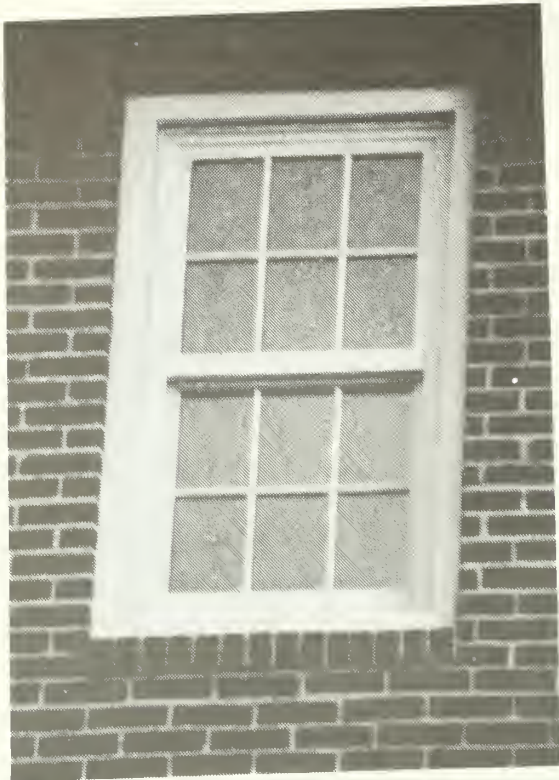
6. Proposed replacement window, exterior. Note rectangular panning, extensive subframe creating additional shadow lines. Compare the meeting rail and muntin dimensions with the historic sash in 4-5.

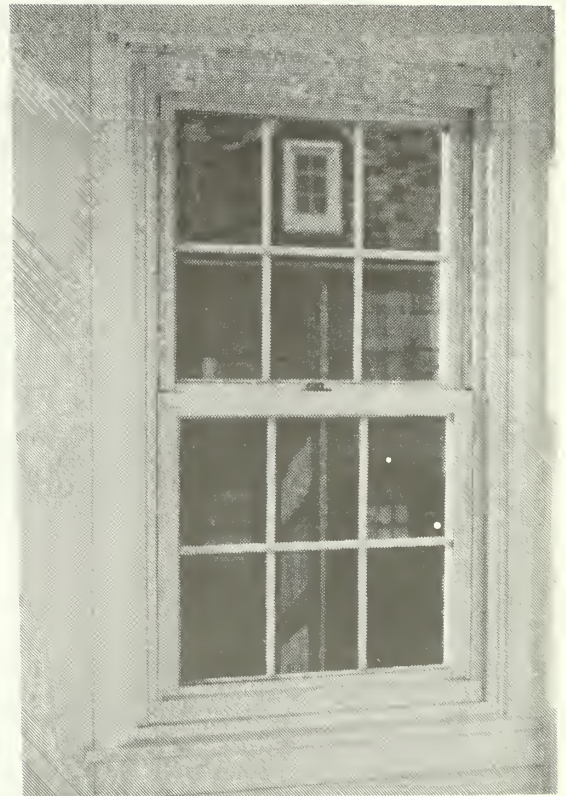
7. Proposed replacement window, interior. Note the three layers of metal comprising the subframe, and the decreased size of the sash and glazed surface within the opening.

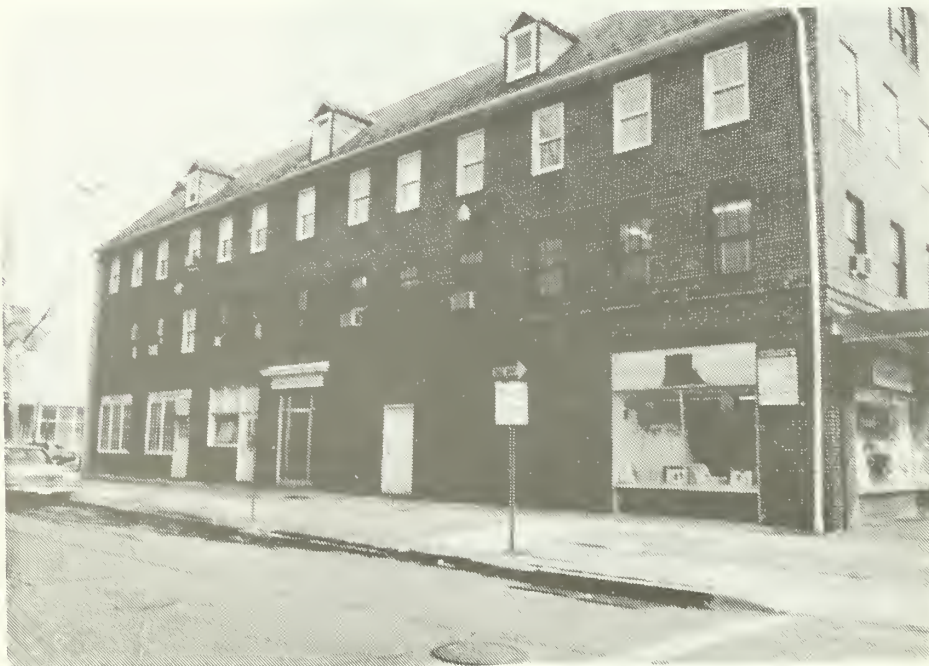
8. Proposed replacement windows on third floor and original windows below. Note how dark sash and frames are unobtrusive, light sash and frames create a striking pattern on the red brick facade.

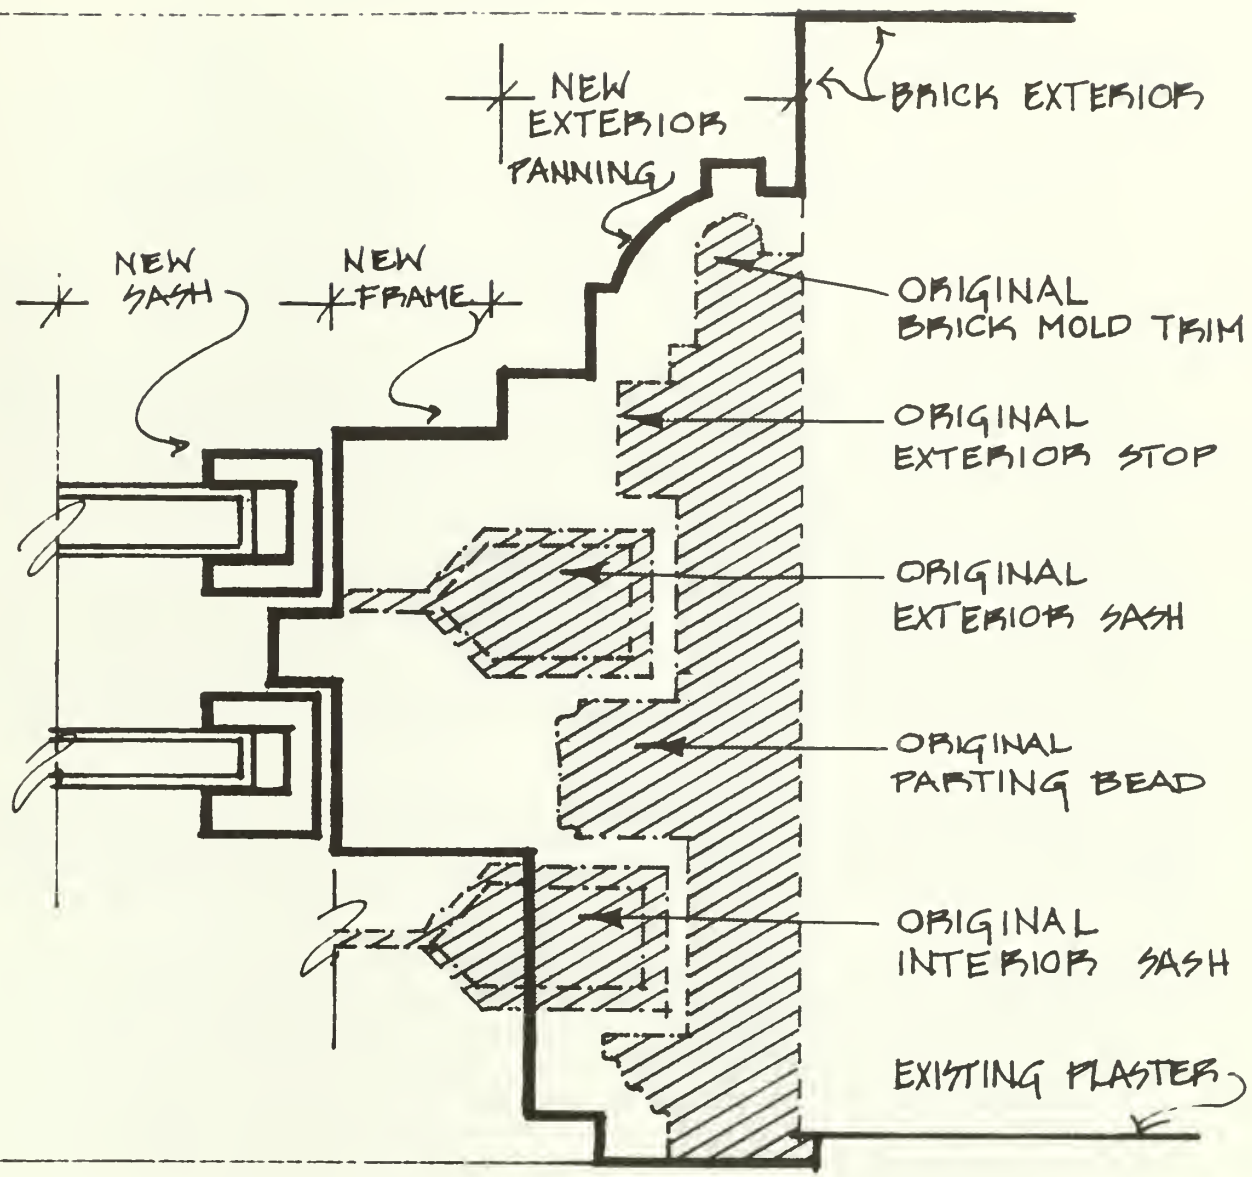
9. Drawing of proposed window and original window and frame location. Note how new sash and frame are set closer to the exterior and within the window opening. The owner's alternative panning identified above will not correct the deficiencies of the sash.

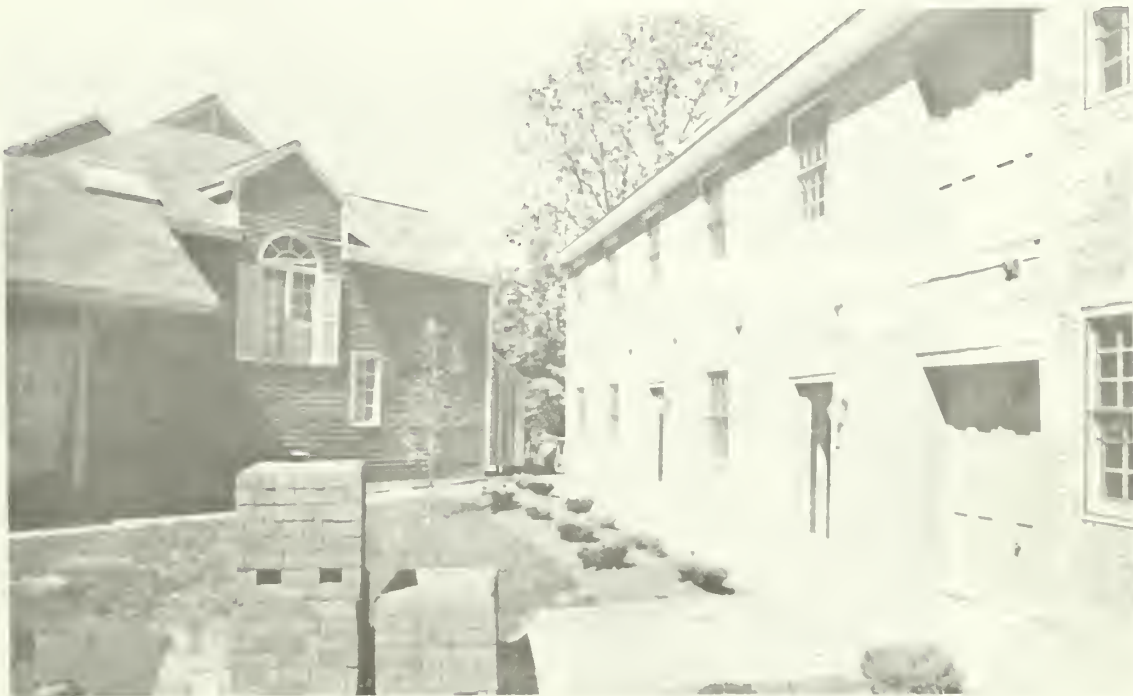
5. Note how close the frame building's new addition is located to the machine shop. A wood deck links the two structures. The new addition has created a more densely developed environment than existed prior to rehabilitation, obstructs the visibility of the machine shop, and has introduced architectural forms and features not found on historic buildings in the district. The new construction, therefore, has changed the visual qualities characteristic of the setting of this district.

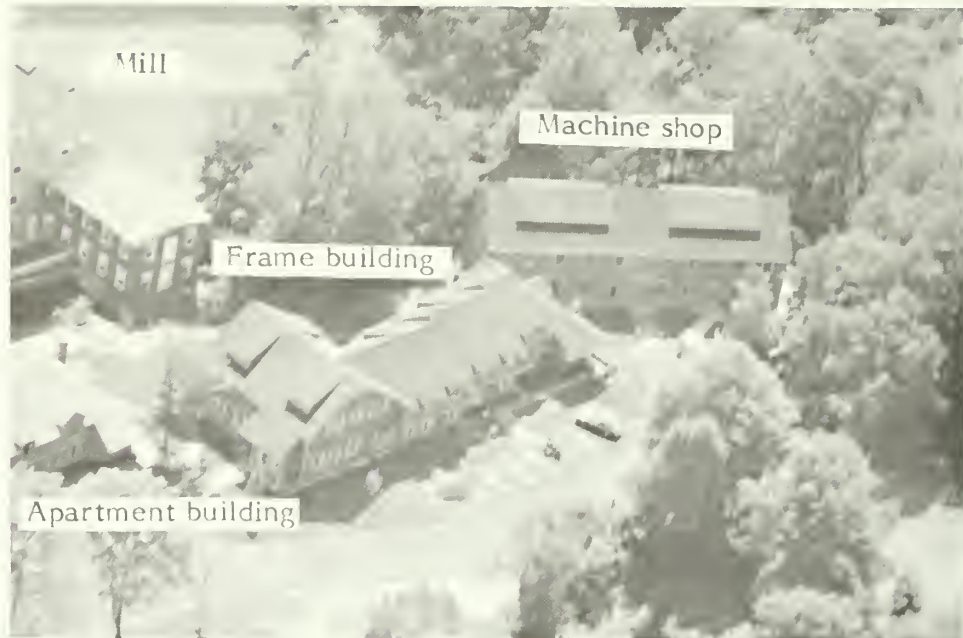
6. Aerial view of this portion of the district showing the alterations to the frame building, and a portion of the free-standing new construction on the left. The machine shop is in the center right of the picture, and the mill is located in the upper left corner. Note the more densely developed environment immediately in front of the machine shop.

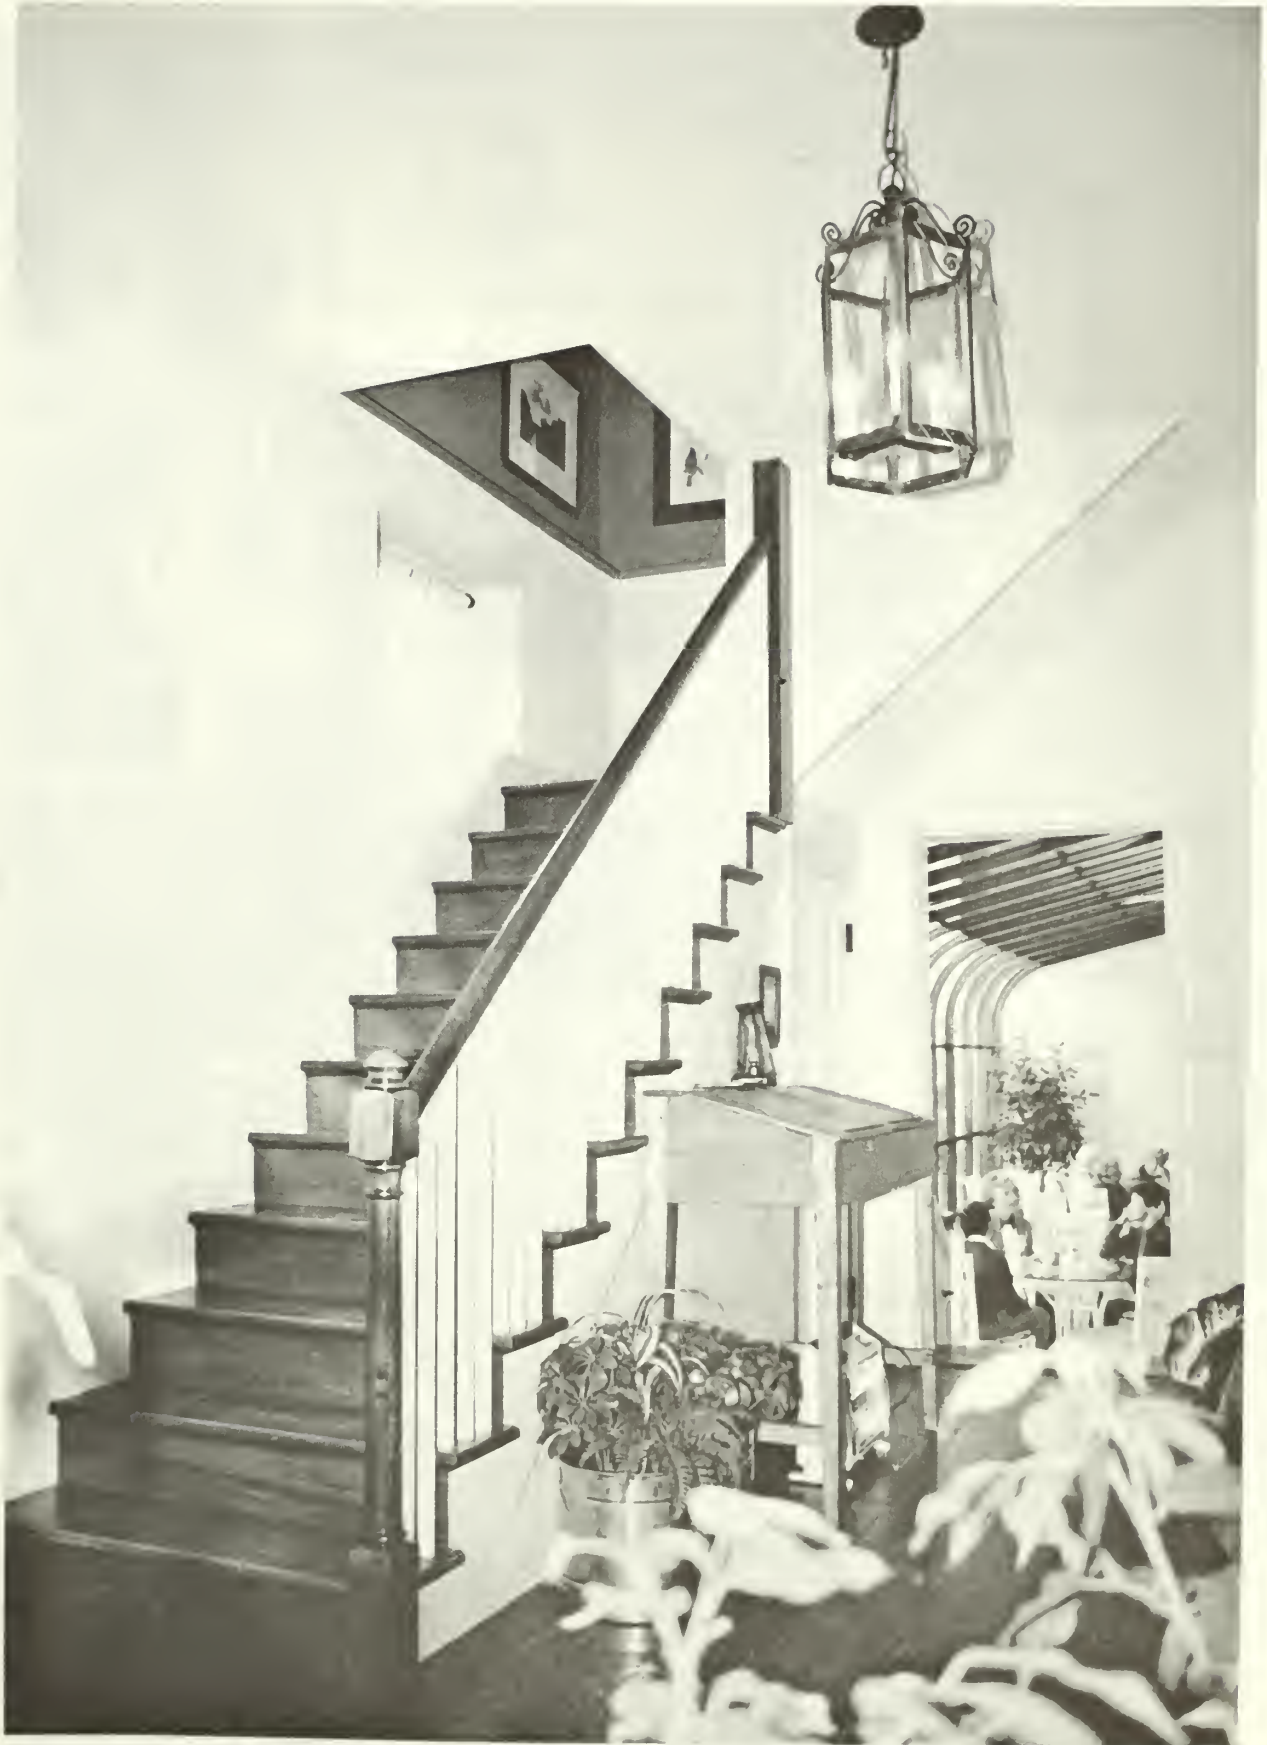
3. New stair after rehabilitation. Design of stair was not based on historic evidence.

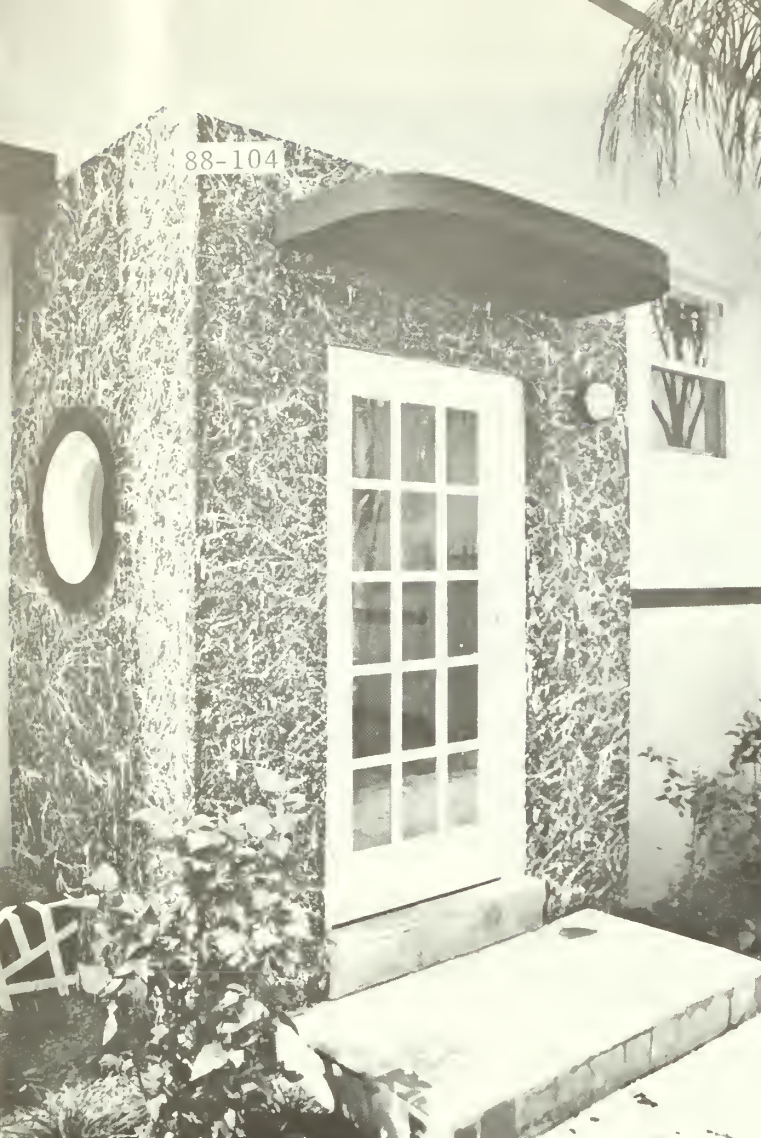
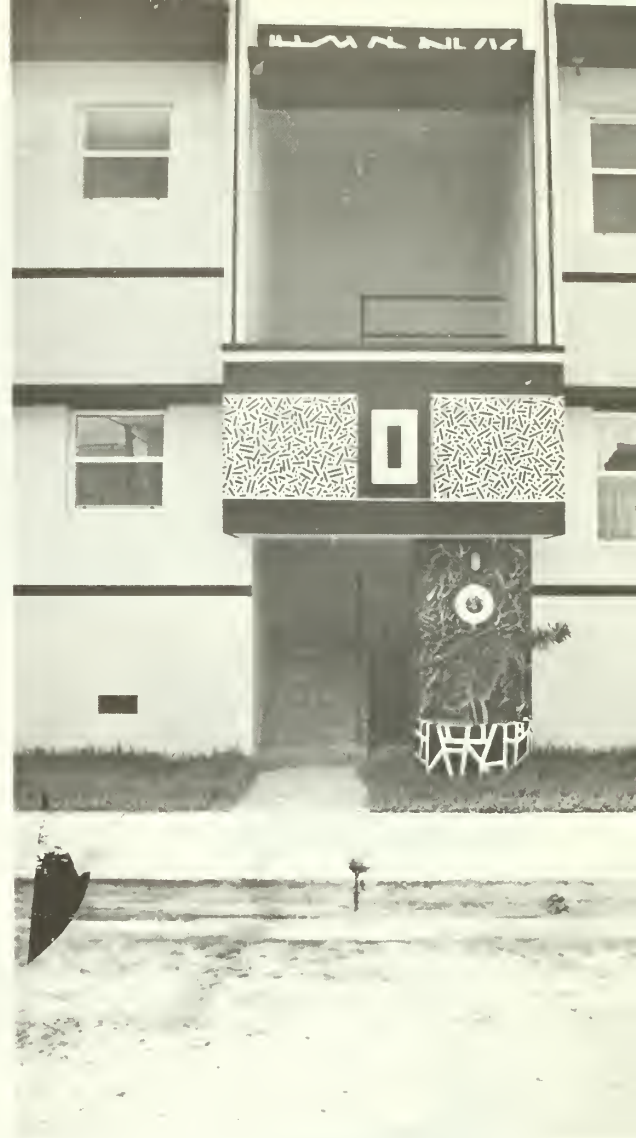
3-5. After rehabilitation the character of the building has been greatly changed by the application of a variety of decorative painted finishes, in particular the "faux" stone surfaces around doors, the contemporary patterned design used above doors and on balconies, and the "cracked tile" pattern on the planters that surround the building.

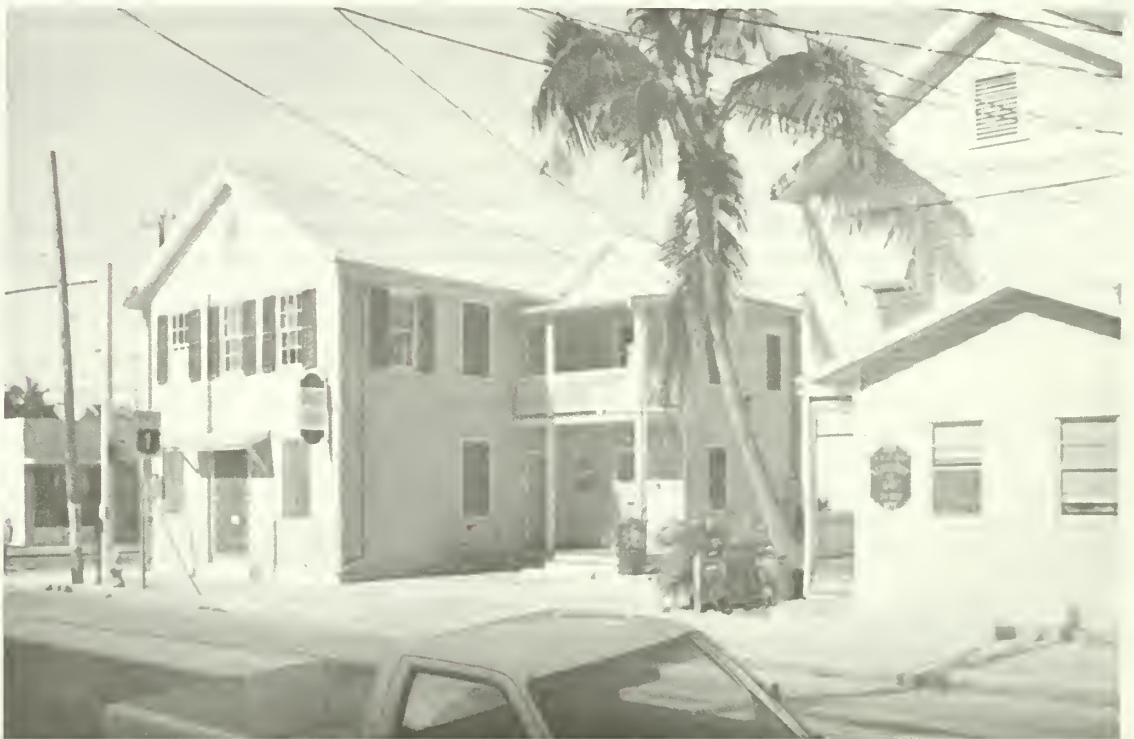
2. With the removal of the staircase there is no longer an indication of the second floor's independence from the first. The two floors of the ell addition appear to be functionally integrated.

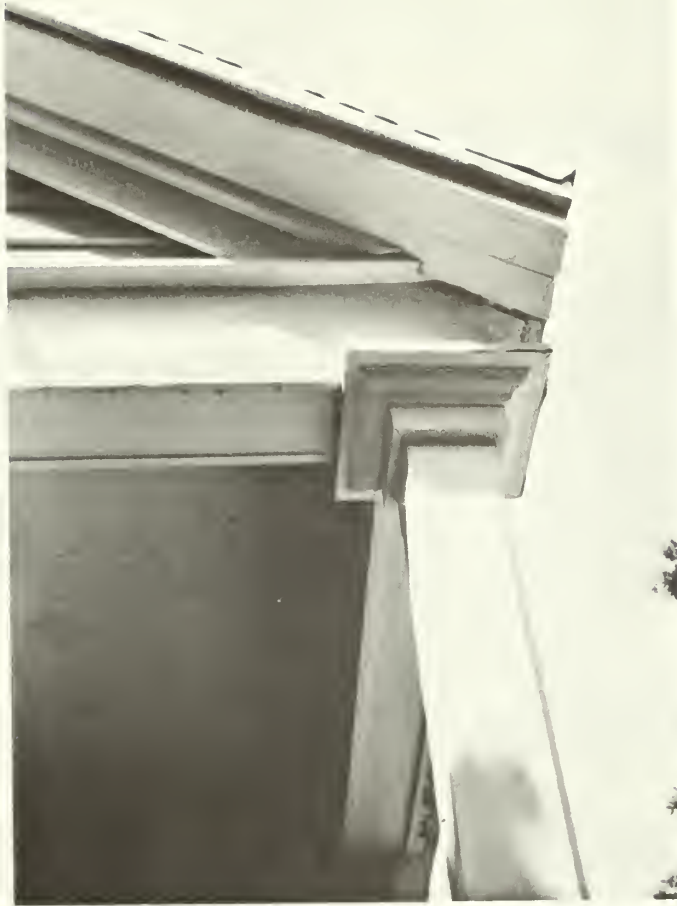
3. Not only have the added features created a non-historic appearance for the facade, but the size of the new capitals does not conform to the narrower dimensions of the overlying gable and causes an awkward overlap of the cornice. Compare with the photograph taken before rehabilitation which reveals the compatible proportions of the turned posts and the gable it supports.
